6 National Dam Inspection Program. Number
Musser Forests Dam (NDIVPA-287,
DER IDV 32-65), Ohio River Basin, McKee
Run, Indiana County, Pennsylvania.

PHASE I ~~REPORT~~ Inspection Report,
NATIONAL DAM INSPECTION PROGRAM

NAME OF DAM: Musser Forests Dam
STATE LOCATED: Pennsylvania
COUNTY LOCATED: Indiana
STREAM: McKee Run
SIZE CLASSIFICATION: Small
HAZARD CLASSIFICATION: High
DATE OF INSPECTION: May 23 and 25, 1979

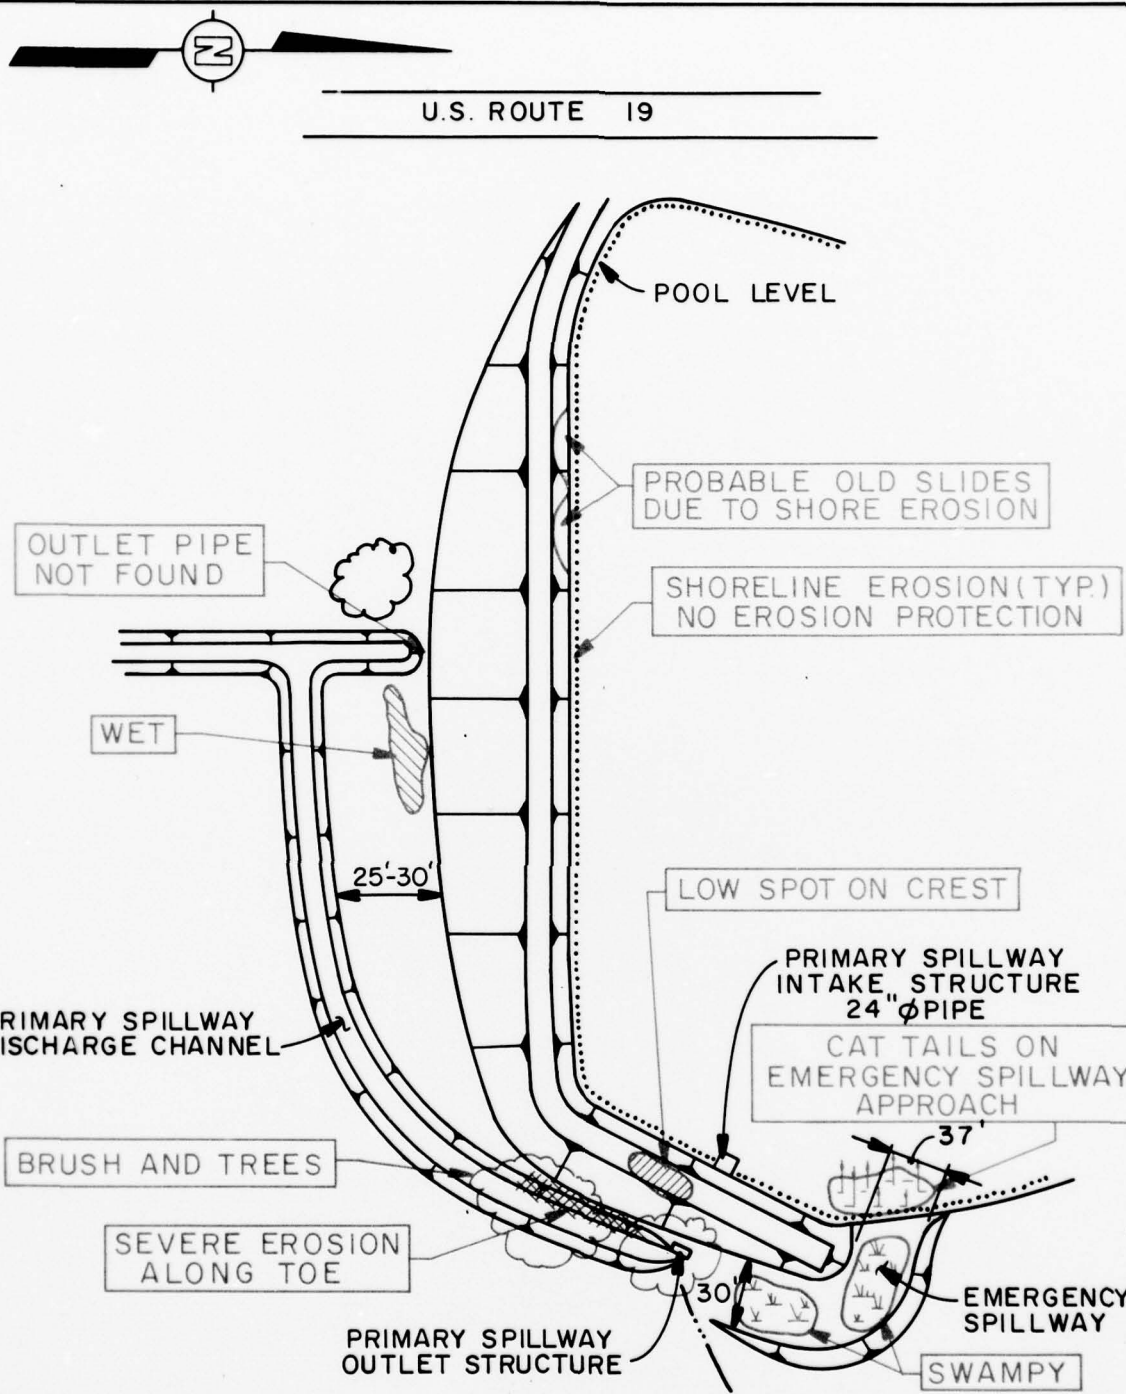
The crest of the dam was surveyed relative to the emergency spillway crest level. The freeboard was found to range from 1.7 feet in the vicinity of the primary spillway to 5.9 feet near the right abutment. The dam crest profile is illustrated on Plate 7.

- POOL LEVEL DATE OF INSPECTION = 0.1 FT. ABOVE PRIMARY SPILLWAY CREST.
- EMERGENCY SPILLWAY FREEBOARD: 1.7 FT.
